ARR No. 5C19

WARTIME REPORT

A COMPARISON OF ANALYTICALLY AND EXPERIMENTALLY
DETERMINED ISOTHERMAL PRESSURE LOSSES IN A
HEAT-EXCHANGER INSTALLATION

By Wesley H. Hillendahl

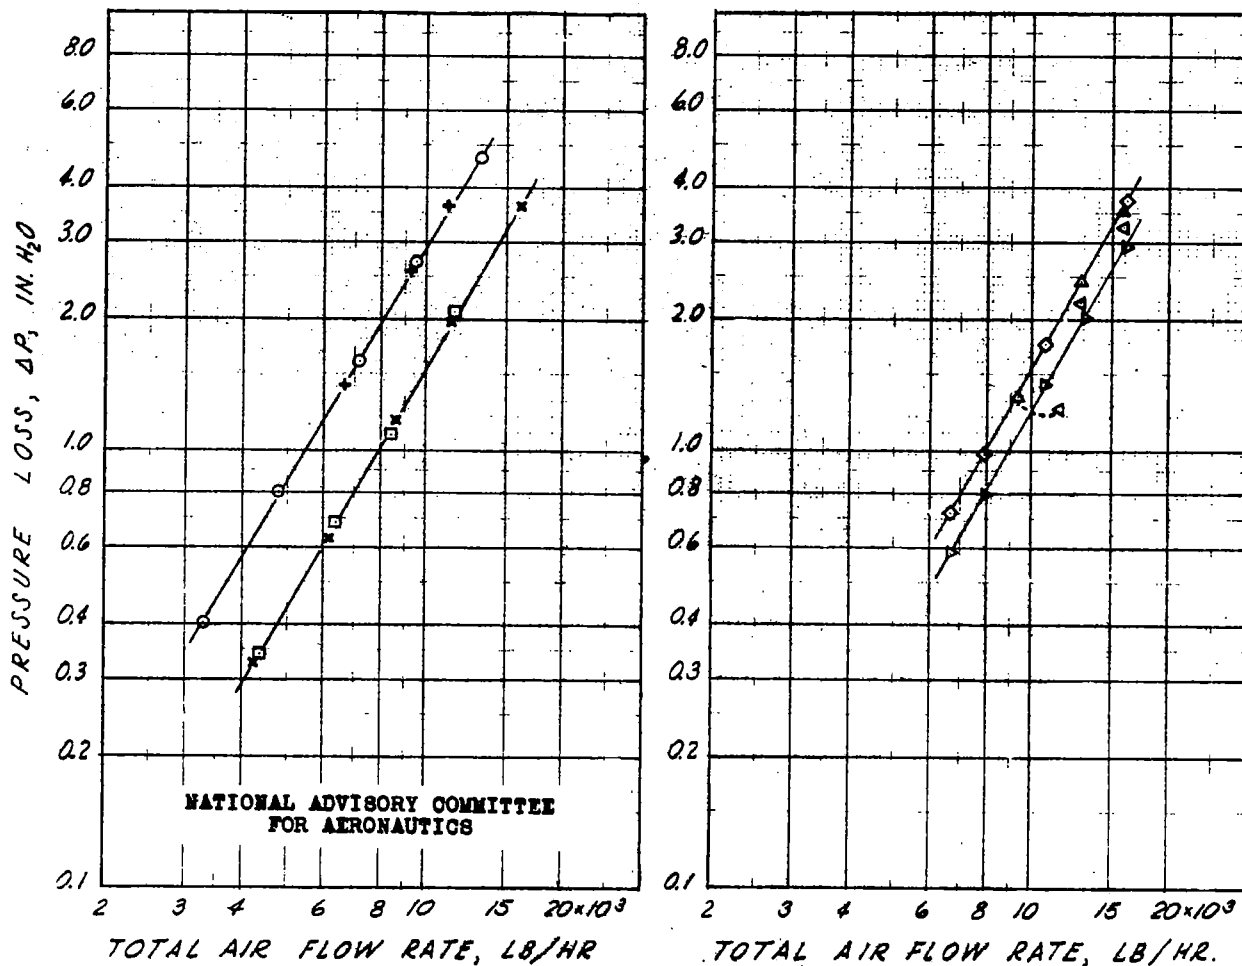
MEASURED OVERALL PRESSURE LOSS OF COMPLETE INSTALLATION ARRANGED AS SHOWN IN FIGURES 9a AND 9b

MEASURED OVERALL PRESSURE LOSS OF COMPLETE INSTALLATION EQUIPPED WITH TRAVERSING SECTIONS AS SHOWN IN FIGURES 9a AND 10a.

FIGURE 13.- COMPARISON OF MEASURED VALUES OF OVERALL PRESSURE LOSS THROUGH THE HEAT-EXCHANGER INSTALLATION WITH AND WITHOUT TRAVERSING SECTIONS BETWEEN HEADERS AND HEAT EXCHANGER.

In order to show the effect of the headers on the pressure loss in the air and gas passages of the heat exchanger, additional data were taken using the arrangements shown in figures 9(a) and 10(a). These data are compared in figure 12 with those taken using the arrangement in figures 7(a) and 7(b). Likewise, to show the effect of the traversing sections (which were installed between the headers and heat exchanger to measure the header losses) on the over-all pressure loss, data taken from the arrangements shown in figures 8(a), 8(b), 9(a), and 10(a) are plotted in figure 13.

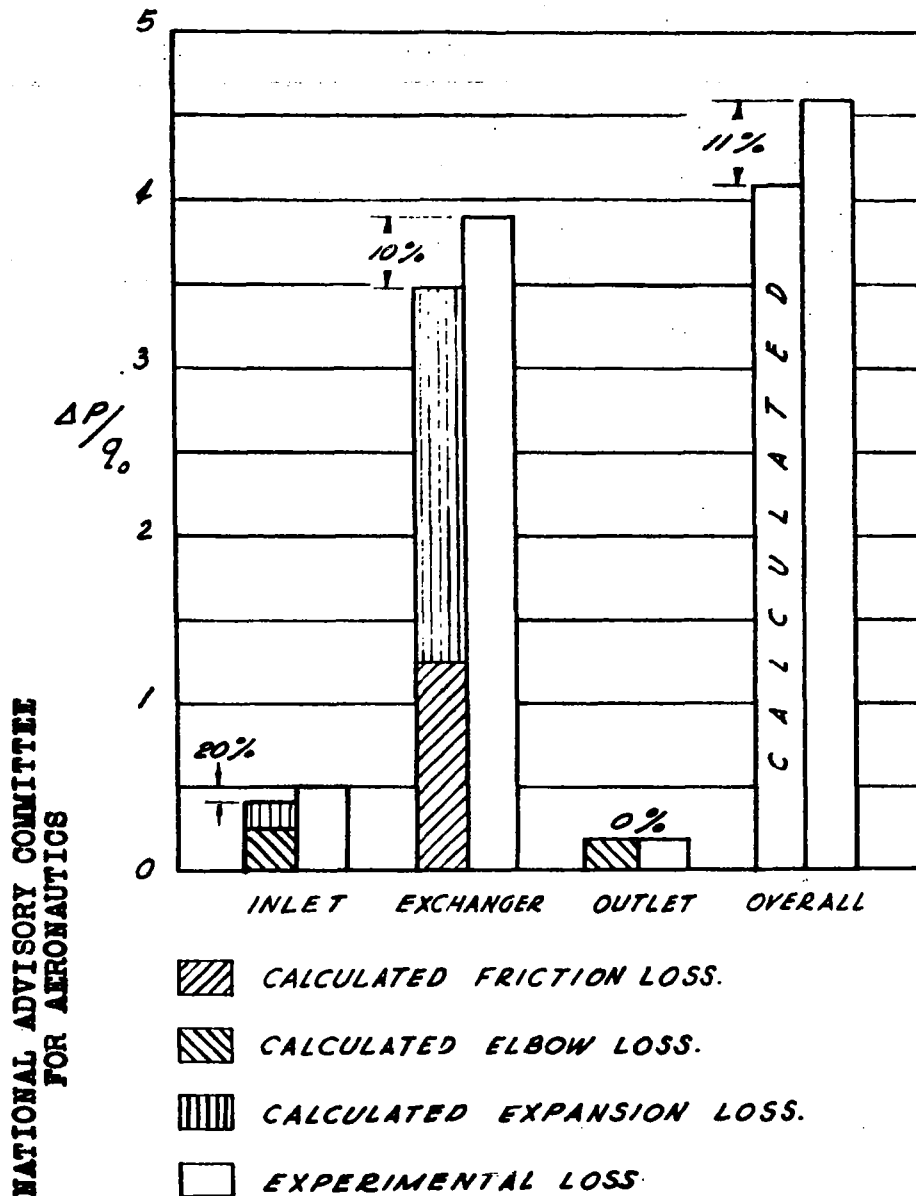
INLET VELOCITY HEAD, q_0 , = 0.90 IN. H_2O
AT FLOW RATE OF 12,000 LB. PER HR.

FIGURE 14.- COMPARISON OF CALCULATED AND MEASURED
VALUES OF $\Delta P/q_0$ FOR THE AIR-SIDE PARTS
OF THE HEAT-EXCHANGER INSTALLATION.

The experimental and analytical results from figures 5, 6(a), and 6(b) are presented in bar-graph form in figures 14 and 15 for comparison of the losses in the component parts. The agreement between the experimental and analytical values for the over-all pressure loss is better than those for the component parts because of the more accurate measurement of over-all pressures.

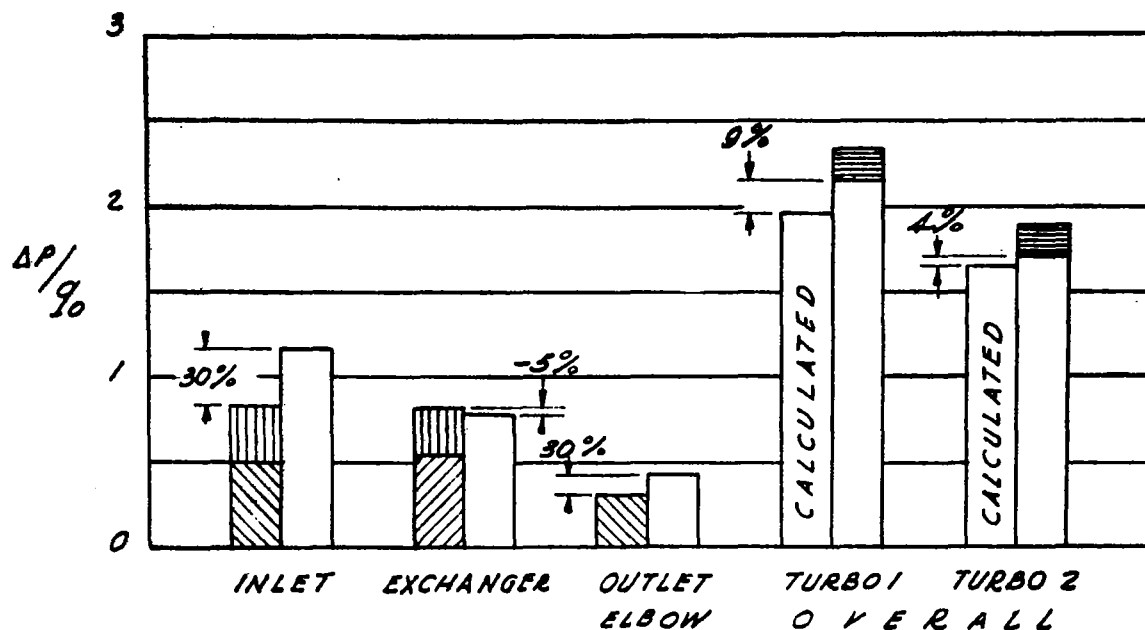
- CALCULATED FRICTION LOSS.
- CALCULATED ELBOW LOSS.
- CALCULATED EXPANSION LOSS.
- EXPERIMENTAL LOSS.
- EXPERIMENTAL ERROR IN MEASURING COMPONENT LOSSES

INLET VELOCITY HEAD, q_0 , = 1.03 IN. H_2O
AT FLOW RATE OF 12,000 LB. PER HR.

FIGURE 15.- COMPARISON OF CALCULATED AND MEASURED VALUES OF $\Delta P/q_0$ FOR THE EXHAUST-GAS-SIDE PARTS OF THE HEAT-EXCHANGER INSTALLATION.

15 the pressure loss in the inlet header is shown to be larger than that in the heat exchanger), but also because of the uneven distribution of flow into the heat exchanger. Flow distribution in the various parts of the installation is shown in figures 16 to 19. It is to be noted that, while the heat exchanger has an appreciable damping effect on the distribution, figure 18 shows the uneven distribution caused by separation in the inlet header to persist into the region downstream of the heat exchanger.

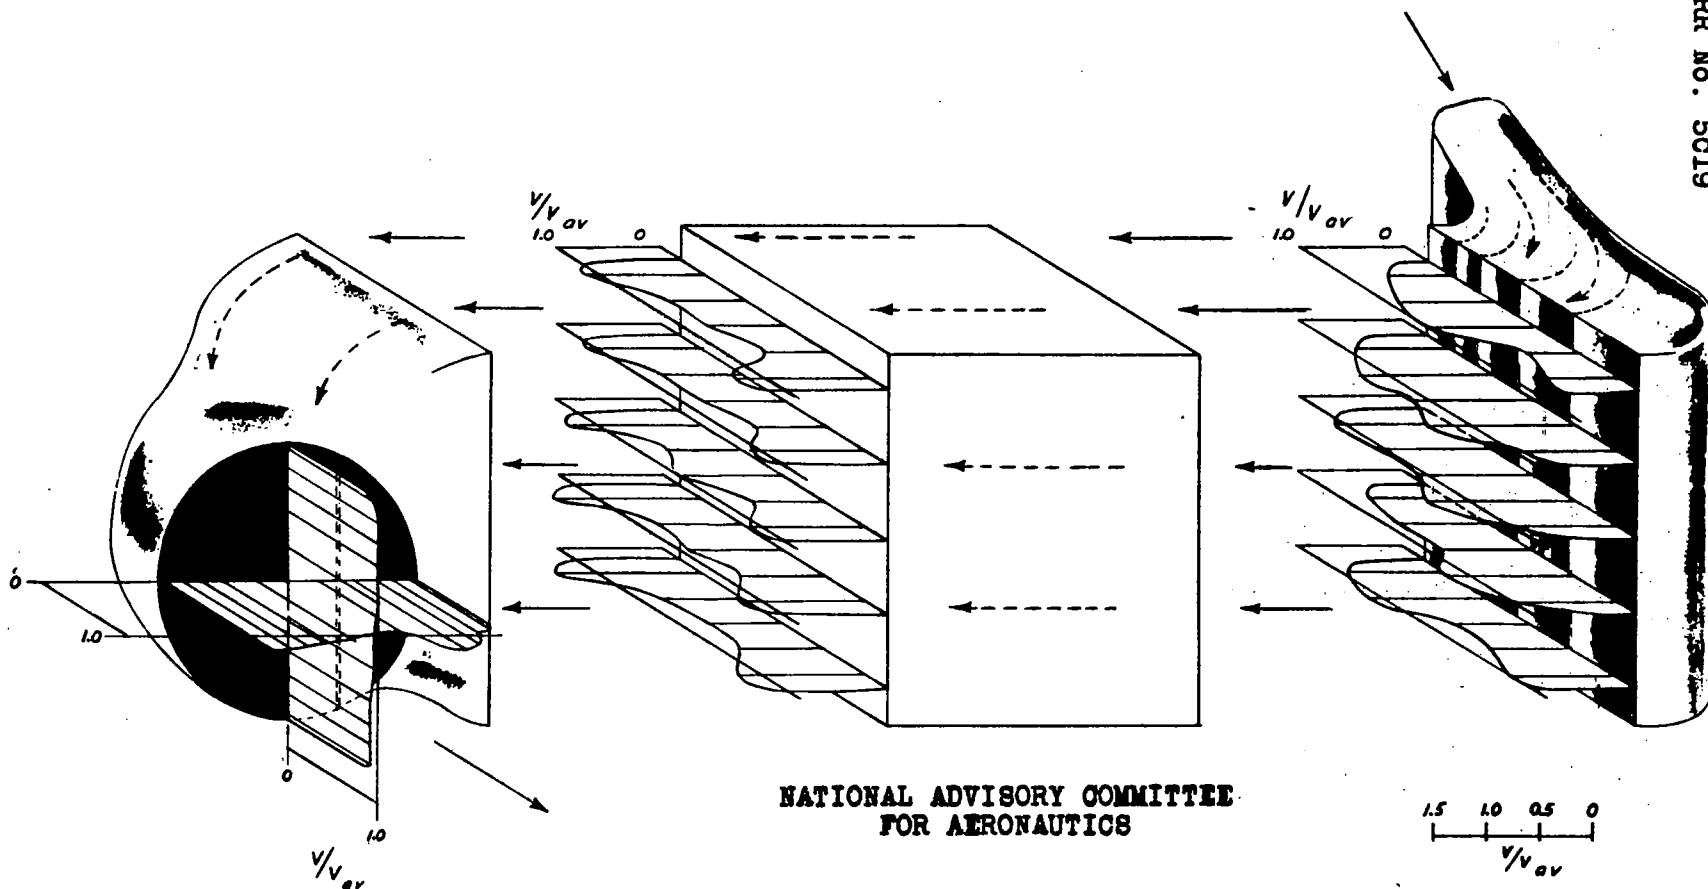
FIGURE 16. - VELOCITY DISTRIBUTIONS IN THE AIR SIDE OF THE COMPLETE HEAT-EXCHANGER INSTALLATION.

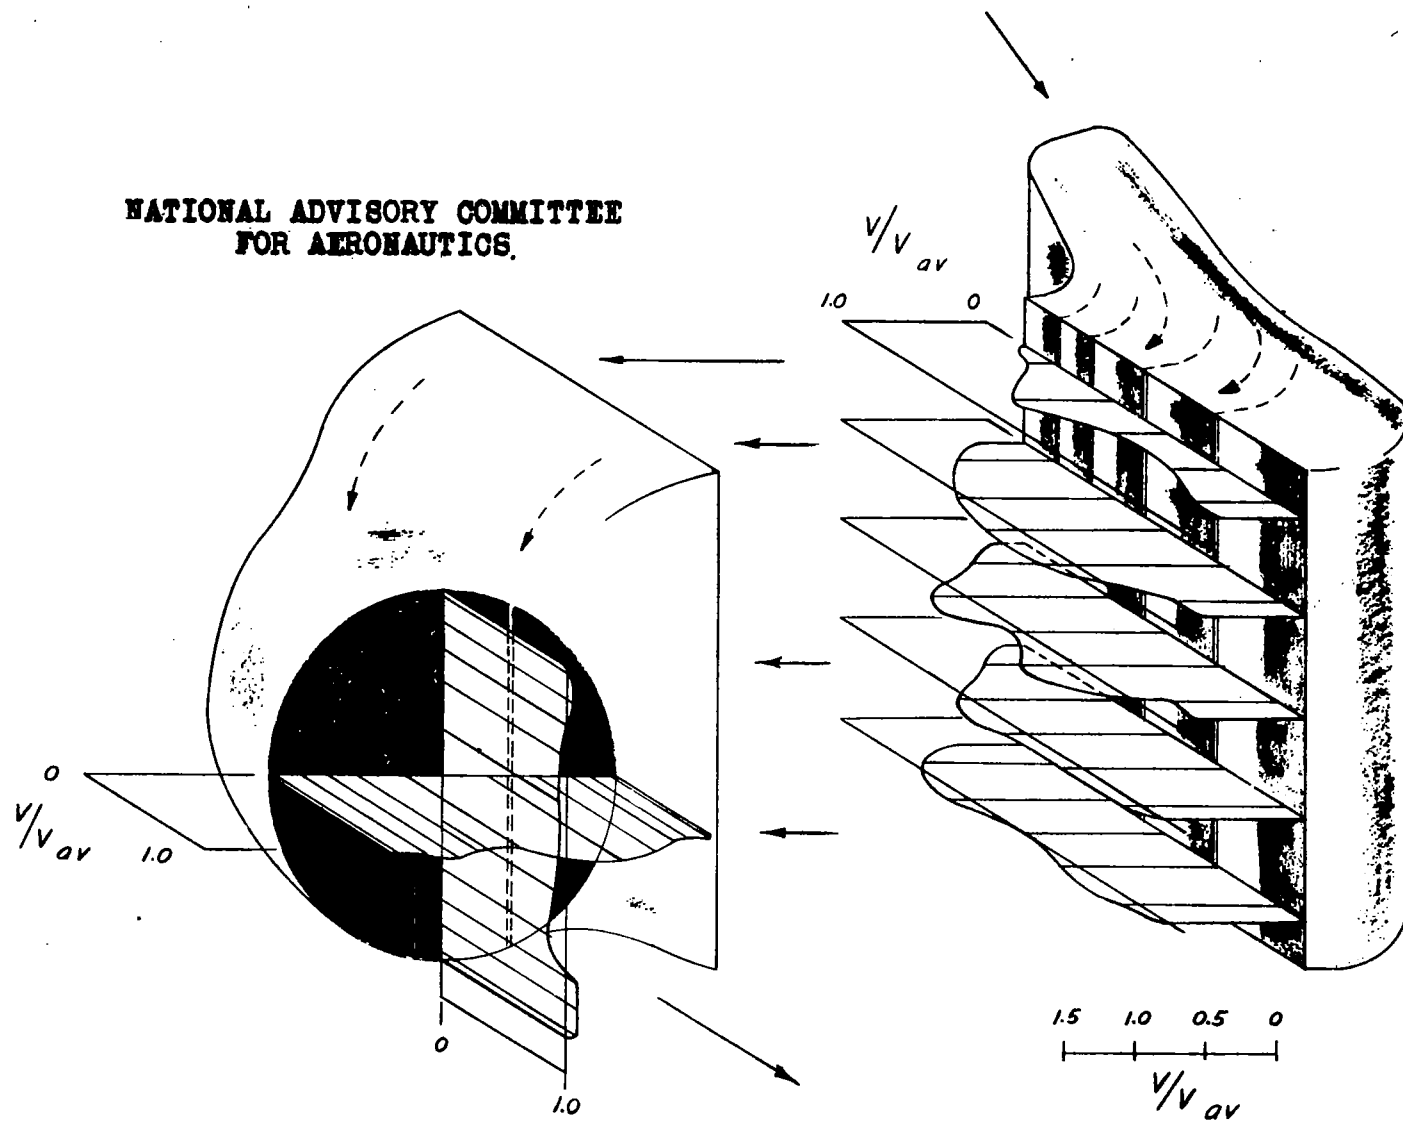
FIGURE 17.- VELOCITY DISTRIBUTIONS IN THE AIR HEADERS WITH
THE HEAT EXCHANGER REMOVED

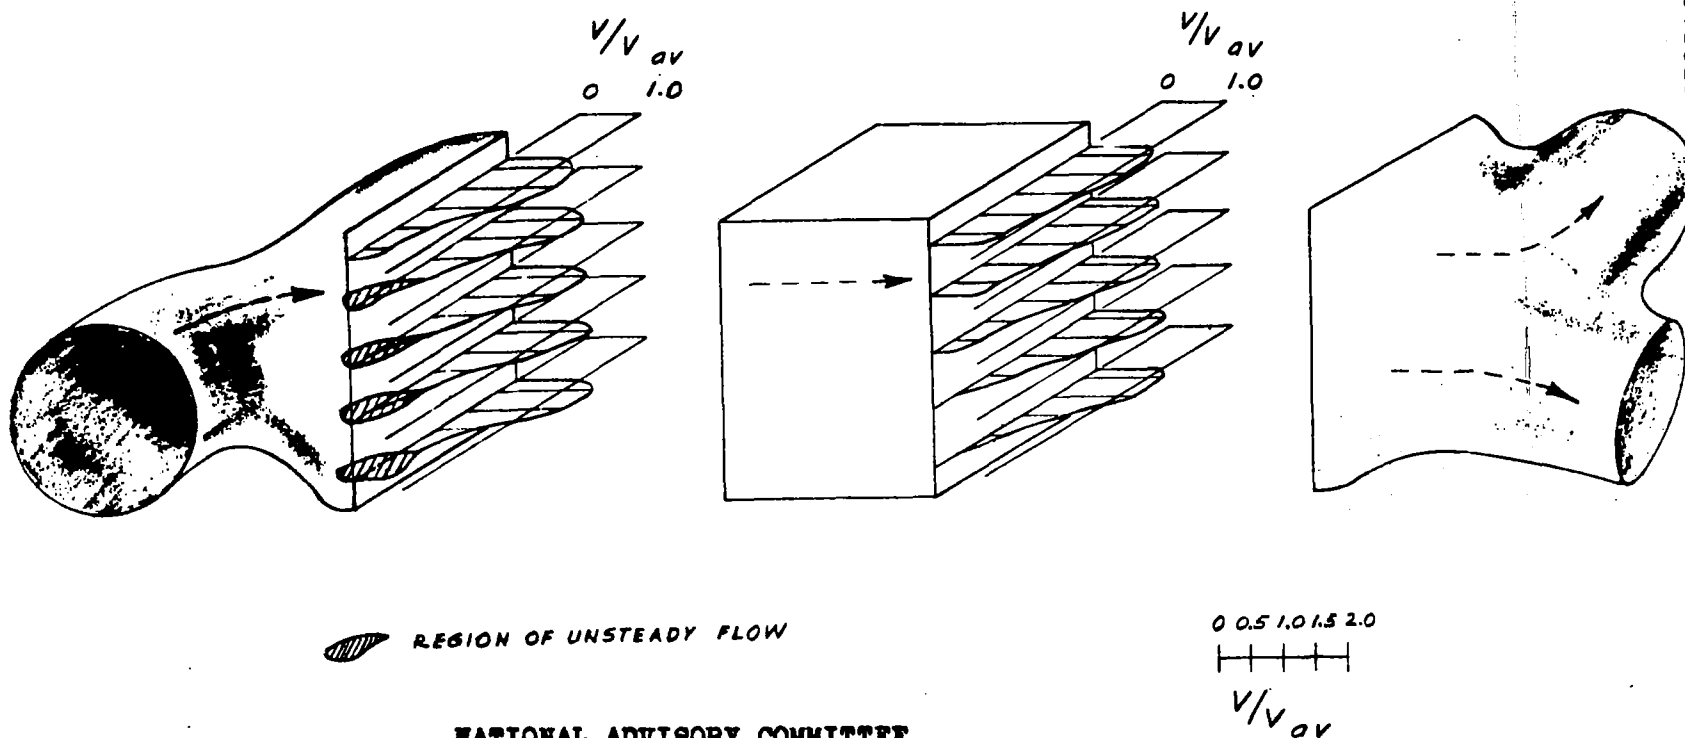
FIGURE 18.- VELOCITY DISTRIBUTIONS IN THE GAS SIDE OF THE COMPLETE HEAT-EXCHANGER INSTALLATION.

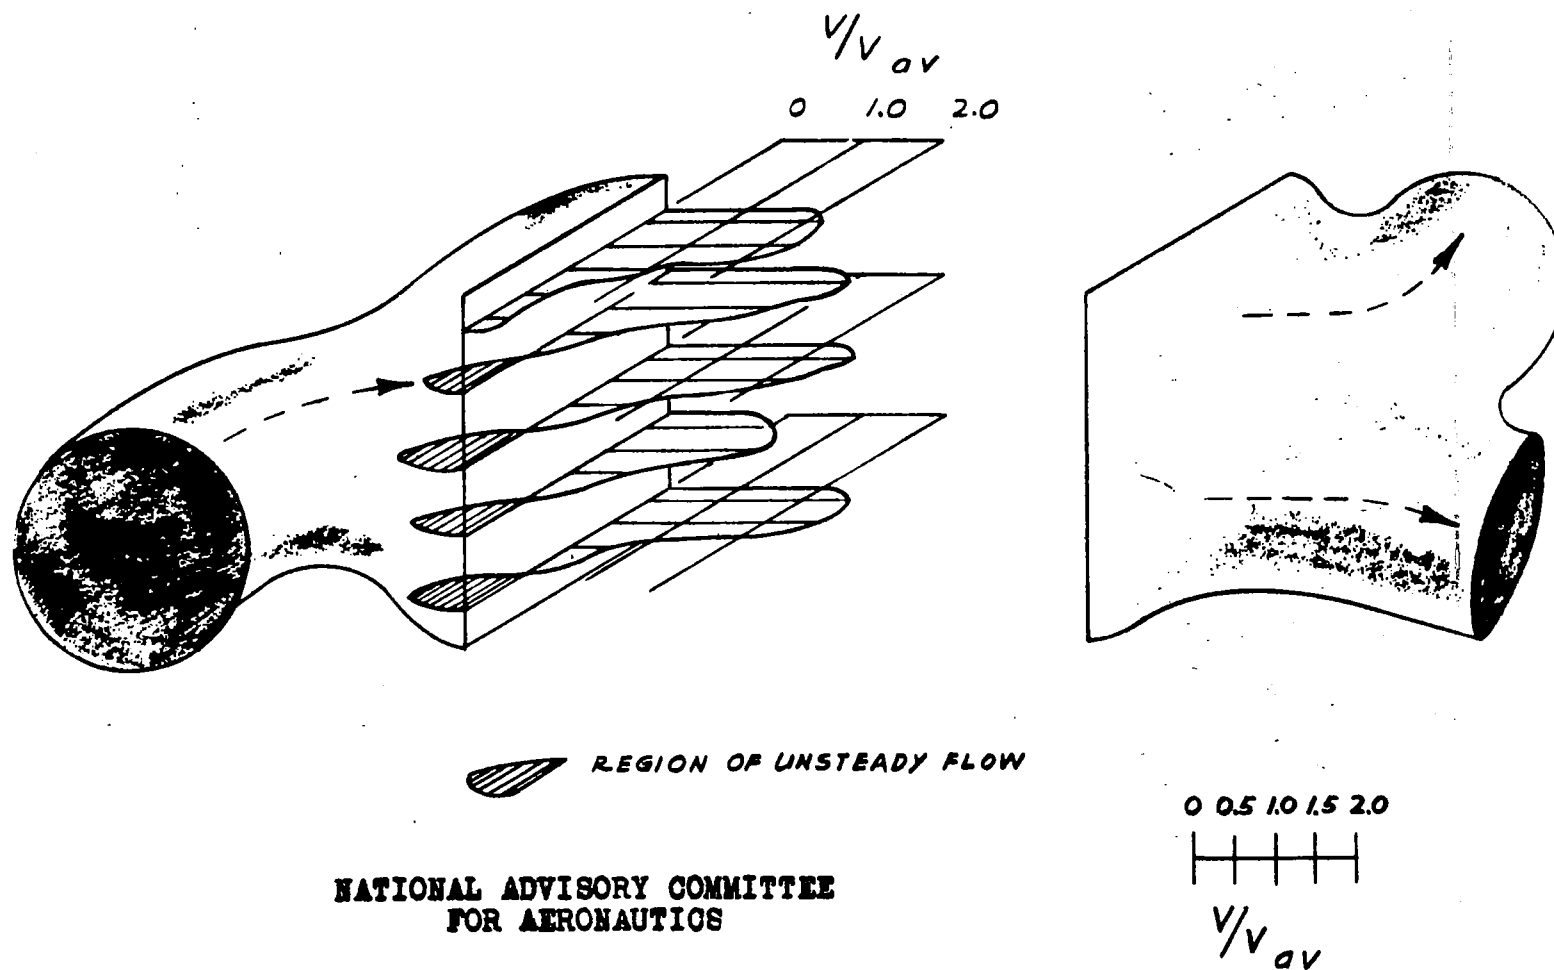
FIGURE 19.- VELOCITY DISTRIBUTIONS IN THE GAS INLET
HEADER WITH THE HEAT EXCHANGER REMOVED.
